Repairing a faulty CI-V on an Icom IC-756 Pro II

Barry GM3YEH

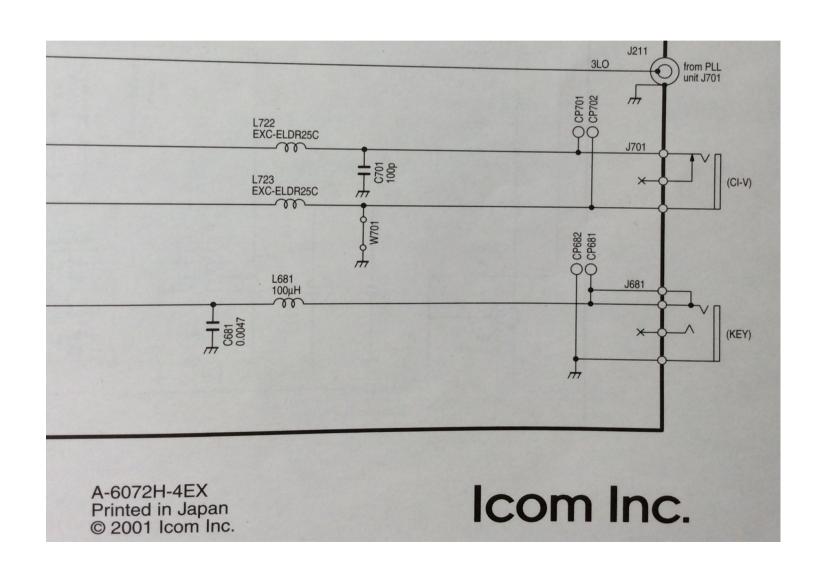
A friend told me about a fault that had developed on the CI-V CAT control of his IC-756 Pro II. After some investigation it was discovered that an SMD ferrite bead on the CI-V ground line could become open circuit. This fault can happen if the computer and the transceiver have different ground potentials (due to not having their grounds electrically bonded together). This turned out to be the fault.

W701 is faulty

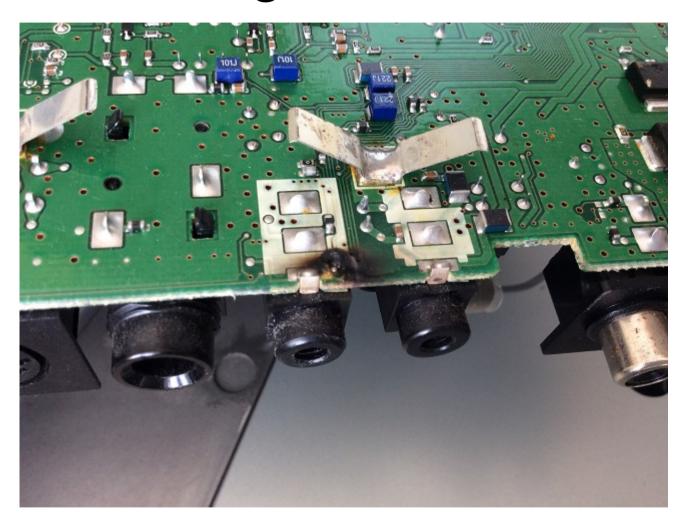
Damage is obvious

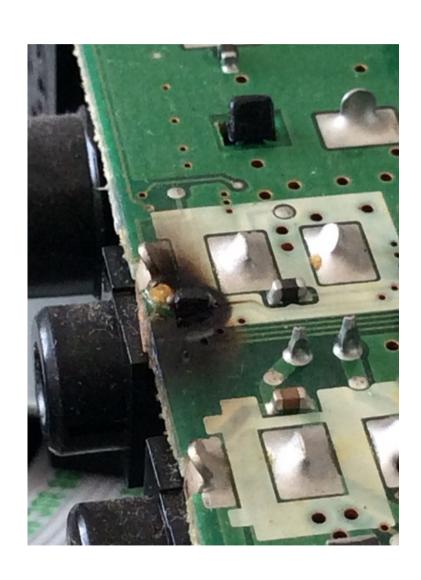
Damaged area needs cleaned

Soft toothbrush and solvent cleaner

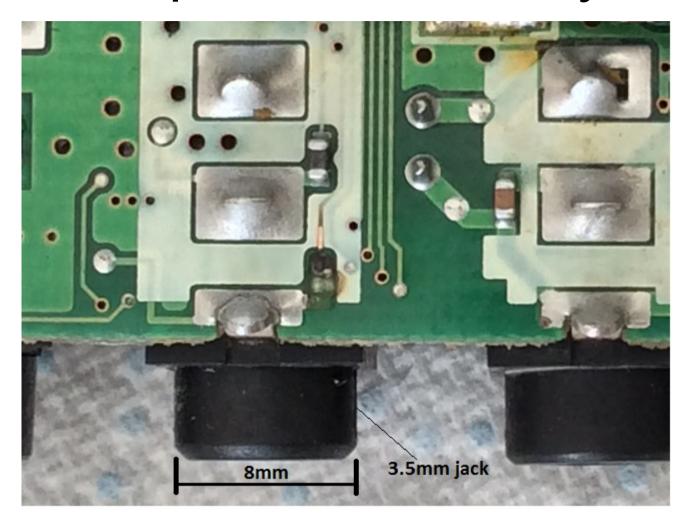
SMD pads are destroyed
